2004 Alaska Airport Pavement Condition Report

Scott Gartin, P.E.
State Pavement Engineer
Statewide Materials Section, Alaska DOT&PF
5800 E. Tudor Road
Phone: (907) 269-6244 Fax: (907) 269-6231
Email: scott_gartin@dot.state.ak.us

TOK JUNCTION AIRPORT - 2004

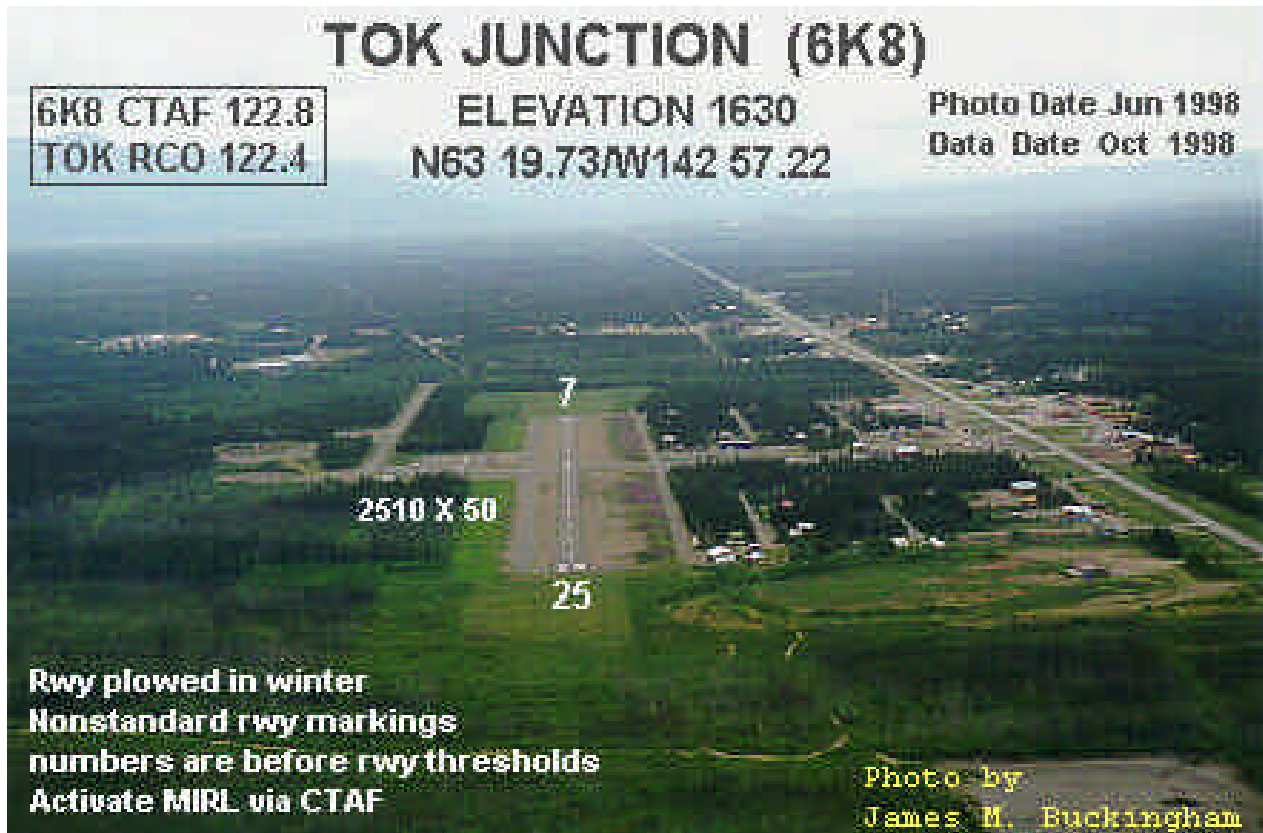
Rwy plowed in winter
Nonstandard rwy markings
numbers are before rwy thresholds
Activate MRL via CTAF

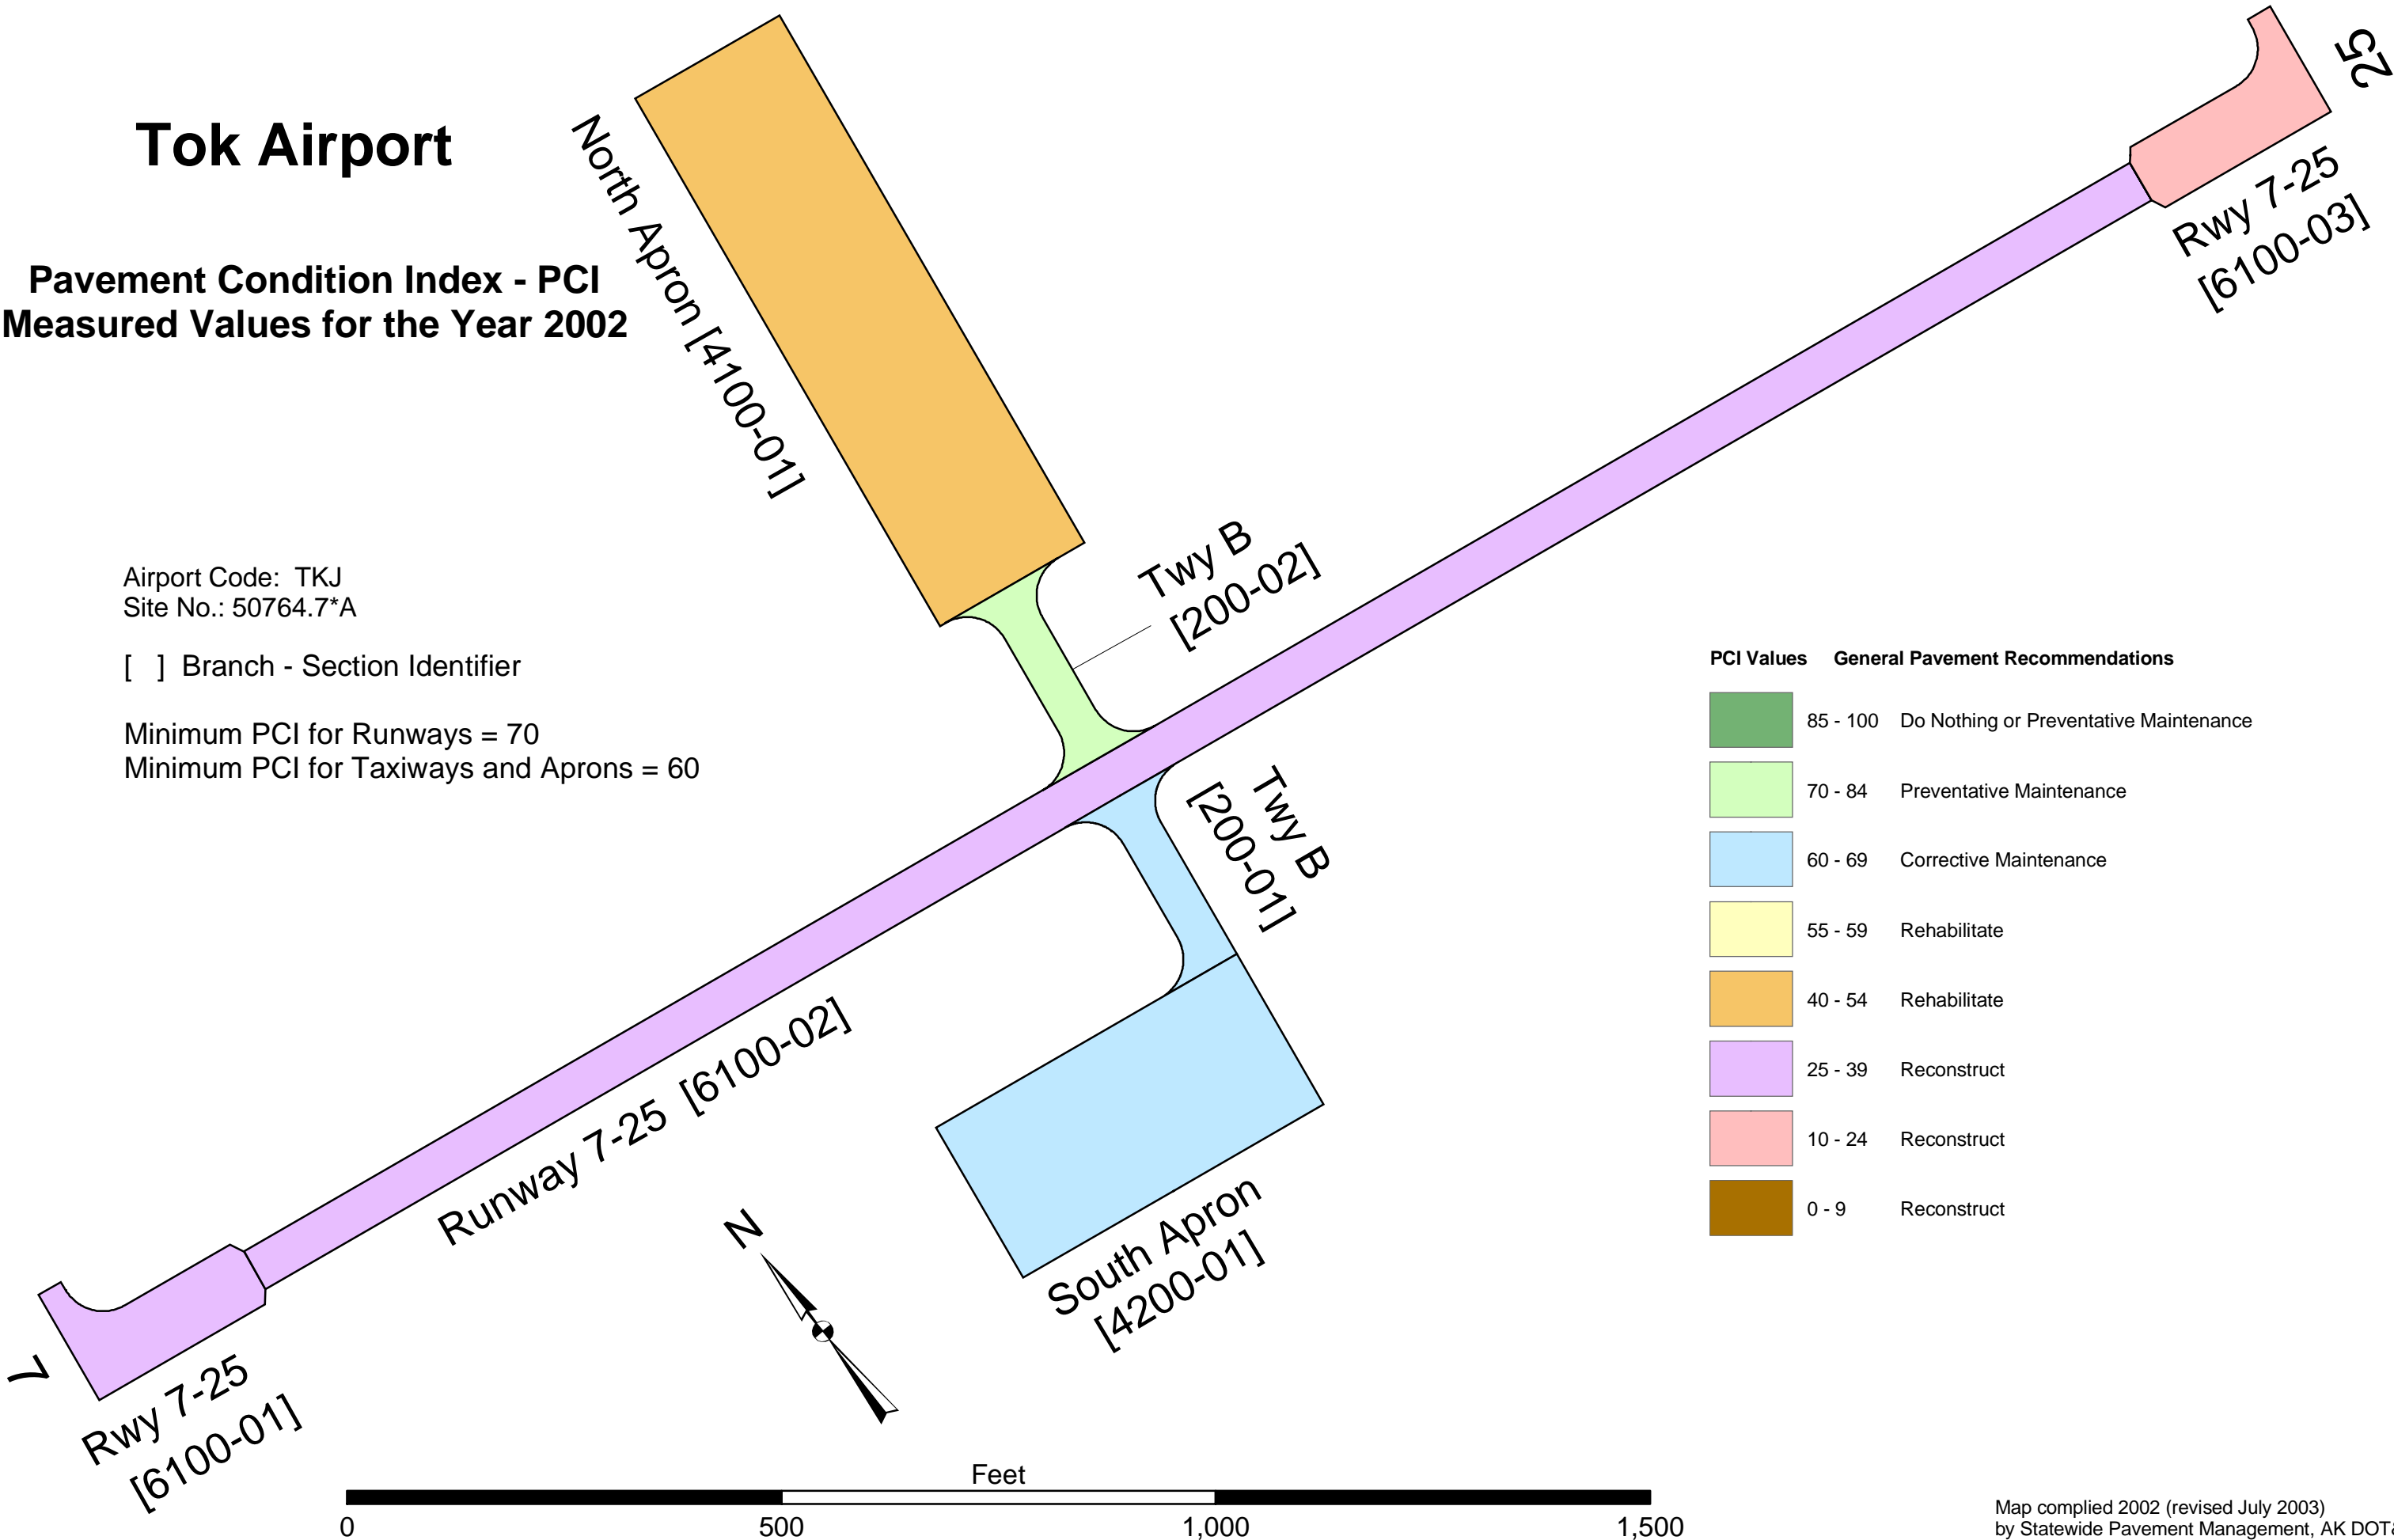
Pavement Condition Index - PCI Measured Values for the Year 2002

Minimum PCI for Runways = 70
Minimum PCI for Taxiways and Aprons = 60

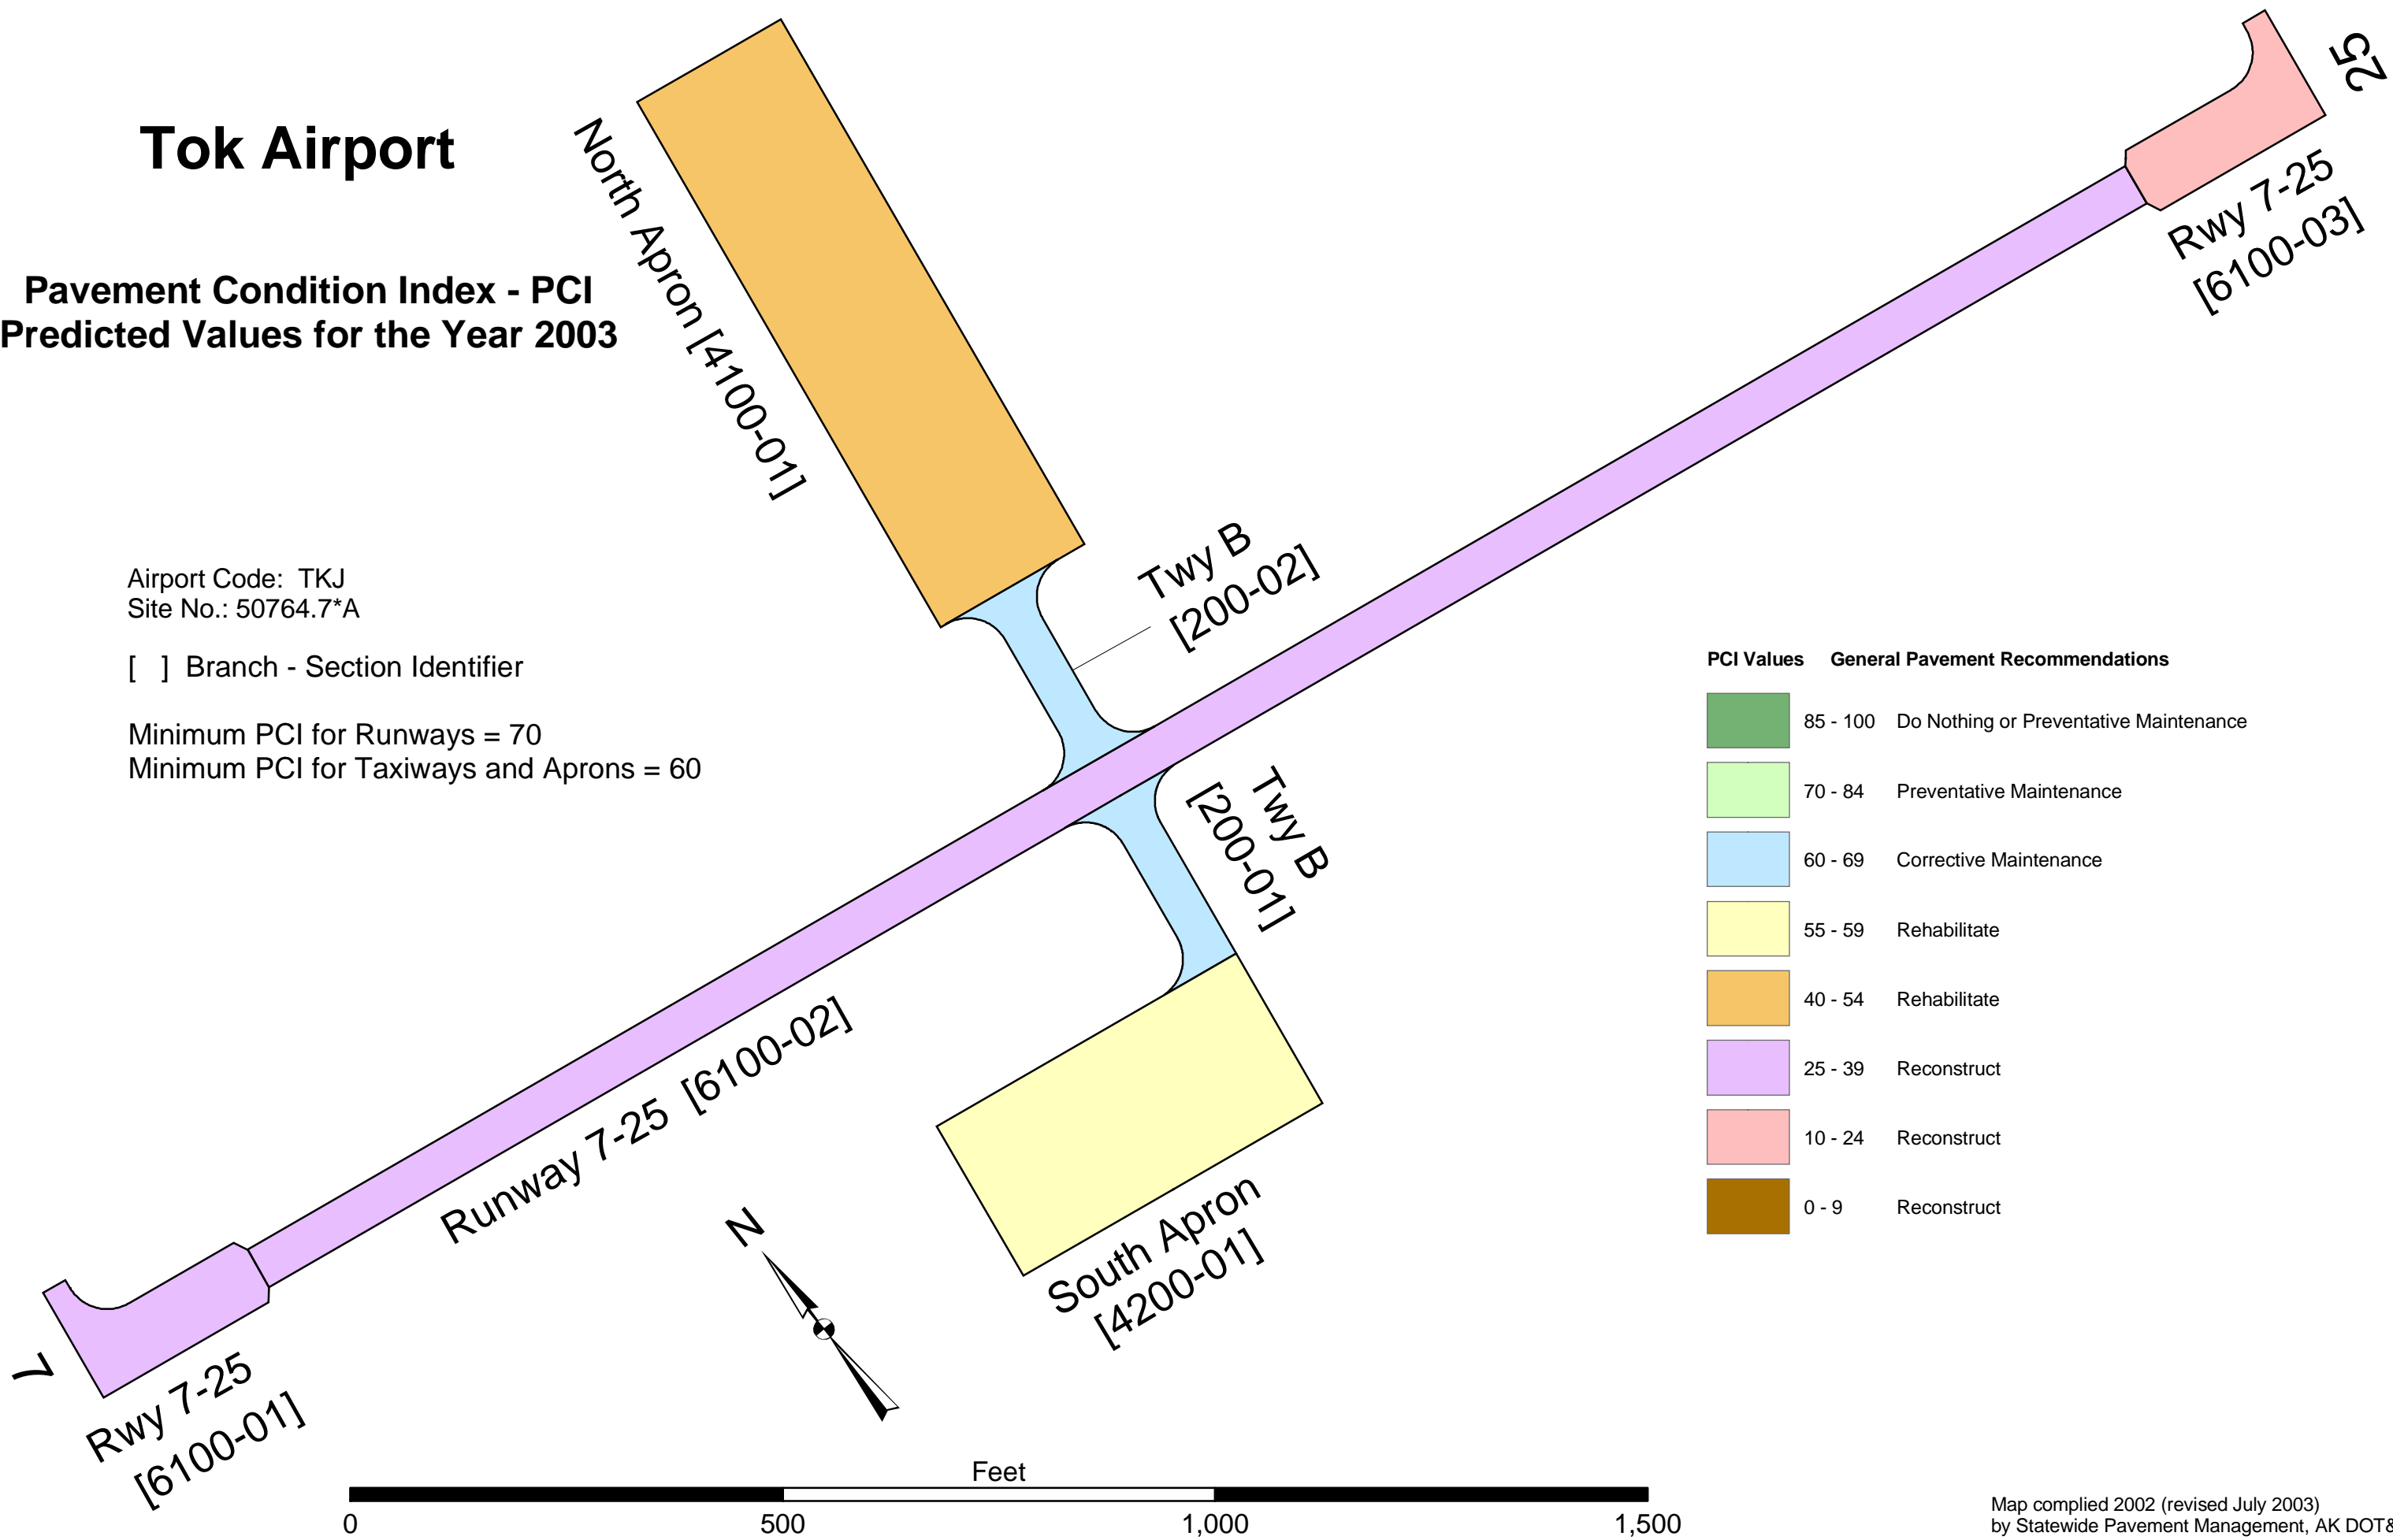
Pavement Condition Index - PCI Predicted Values for the Year 2003

Minimum PCI for Runways = 70
Minimum PCI for Taxiways and Aprons = 60

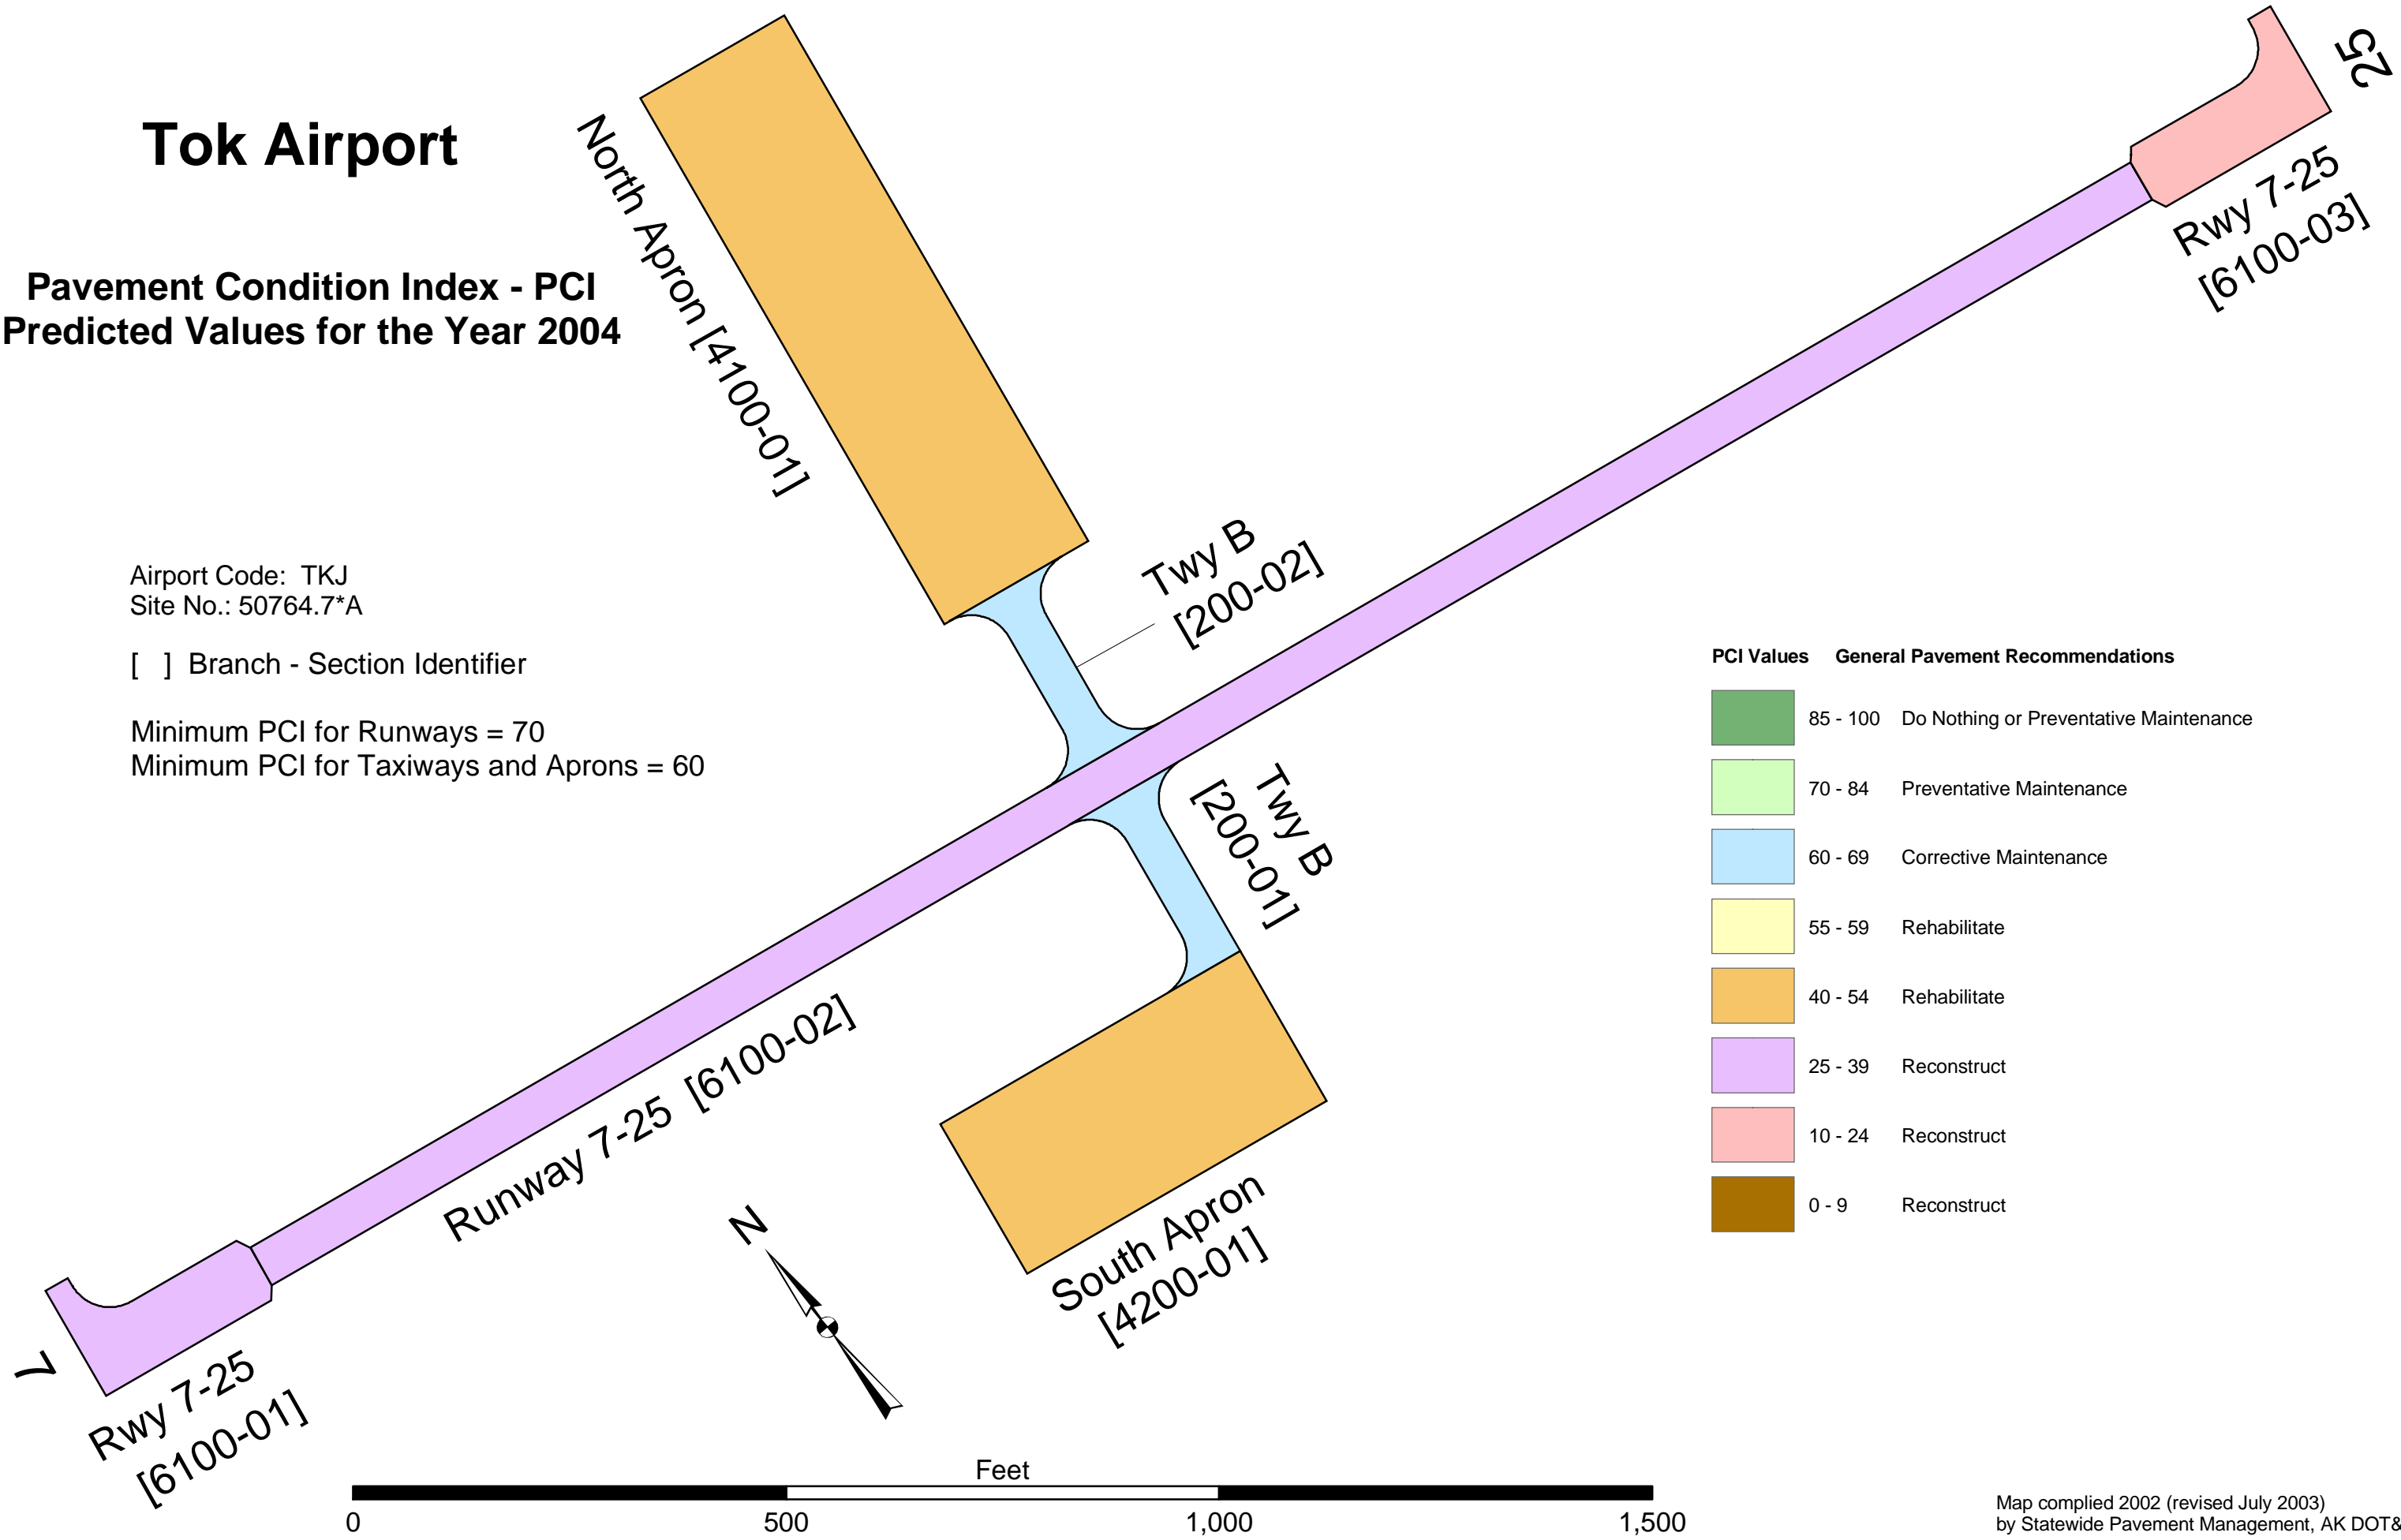
Pavement Condition Index - PCI Predicted Values for the Year 2004

Minimum PCI for Runways = 70
Minimum PCI for Taxiways and Aprons = 60

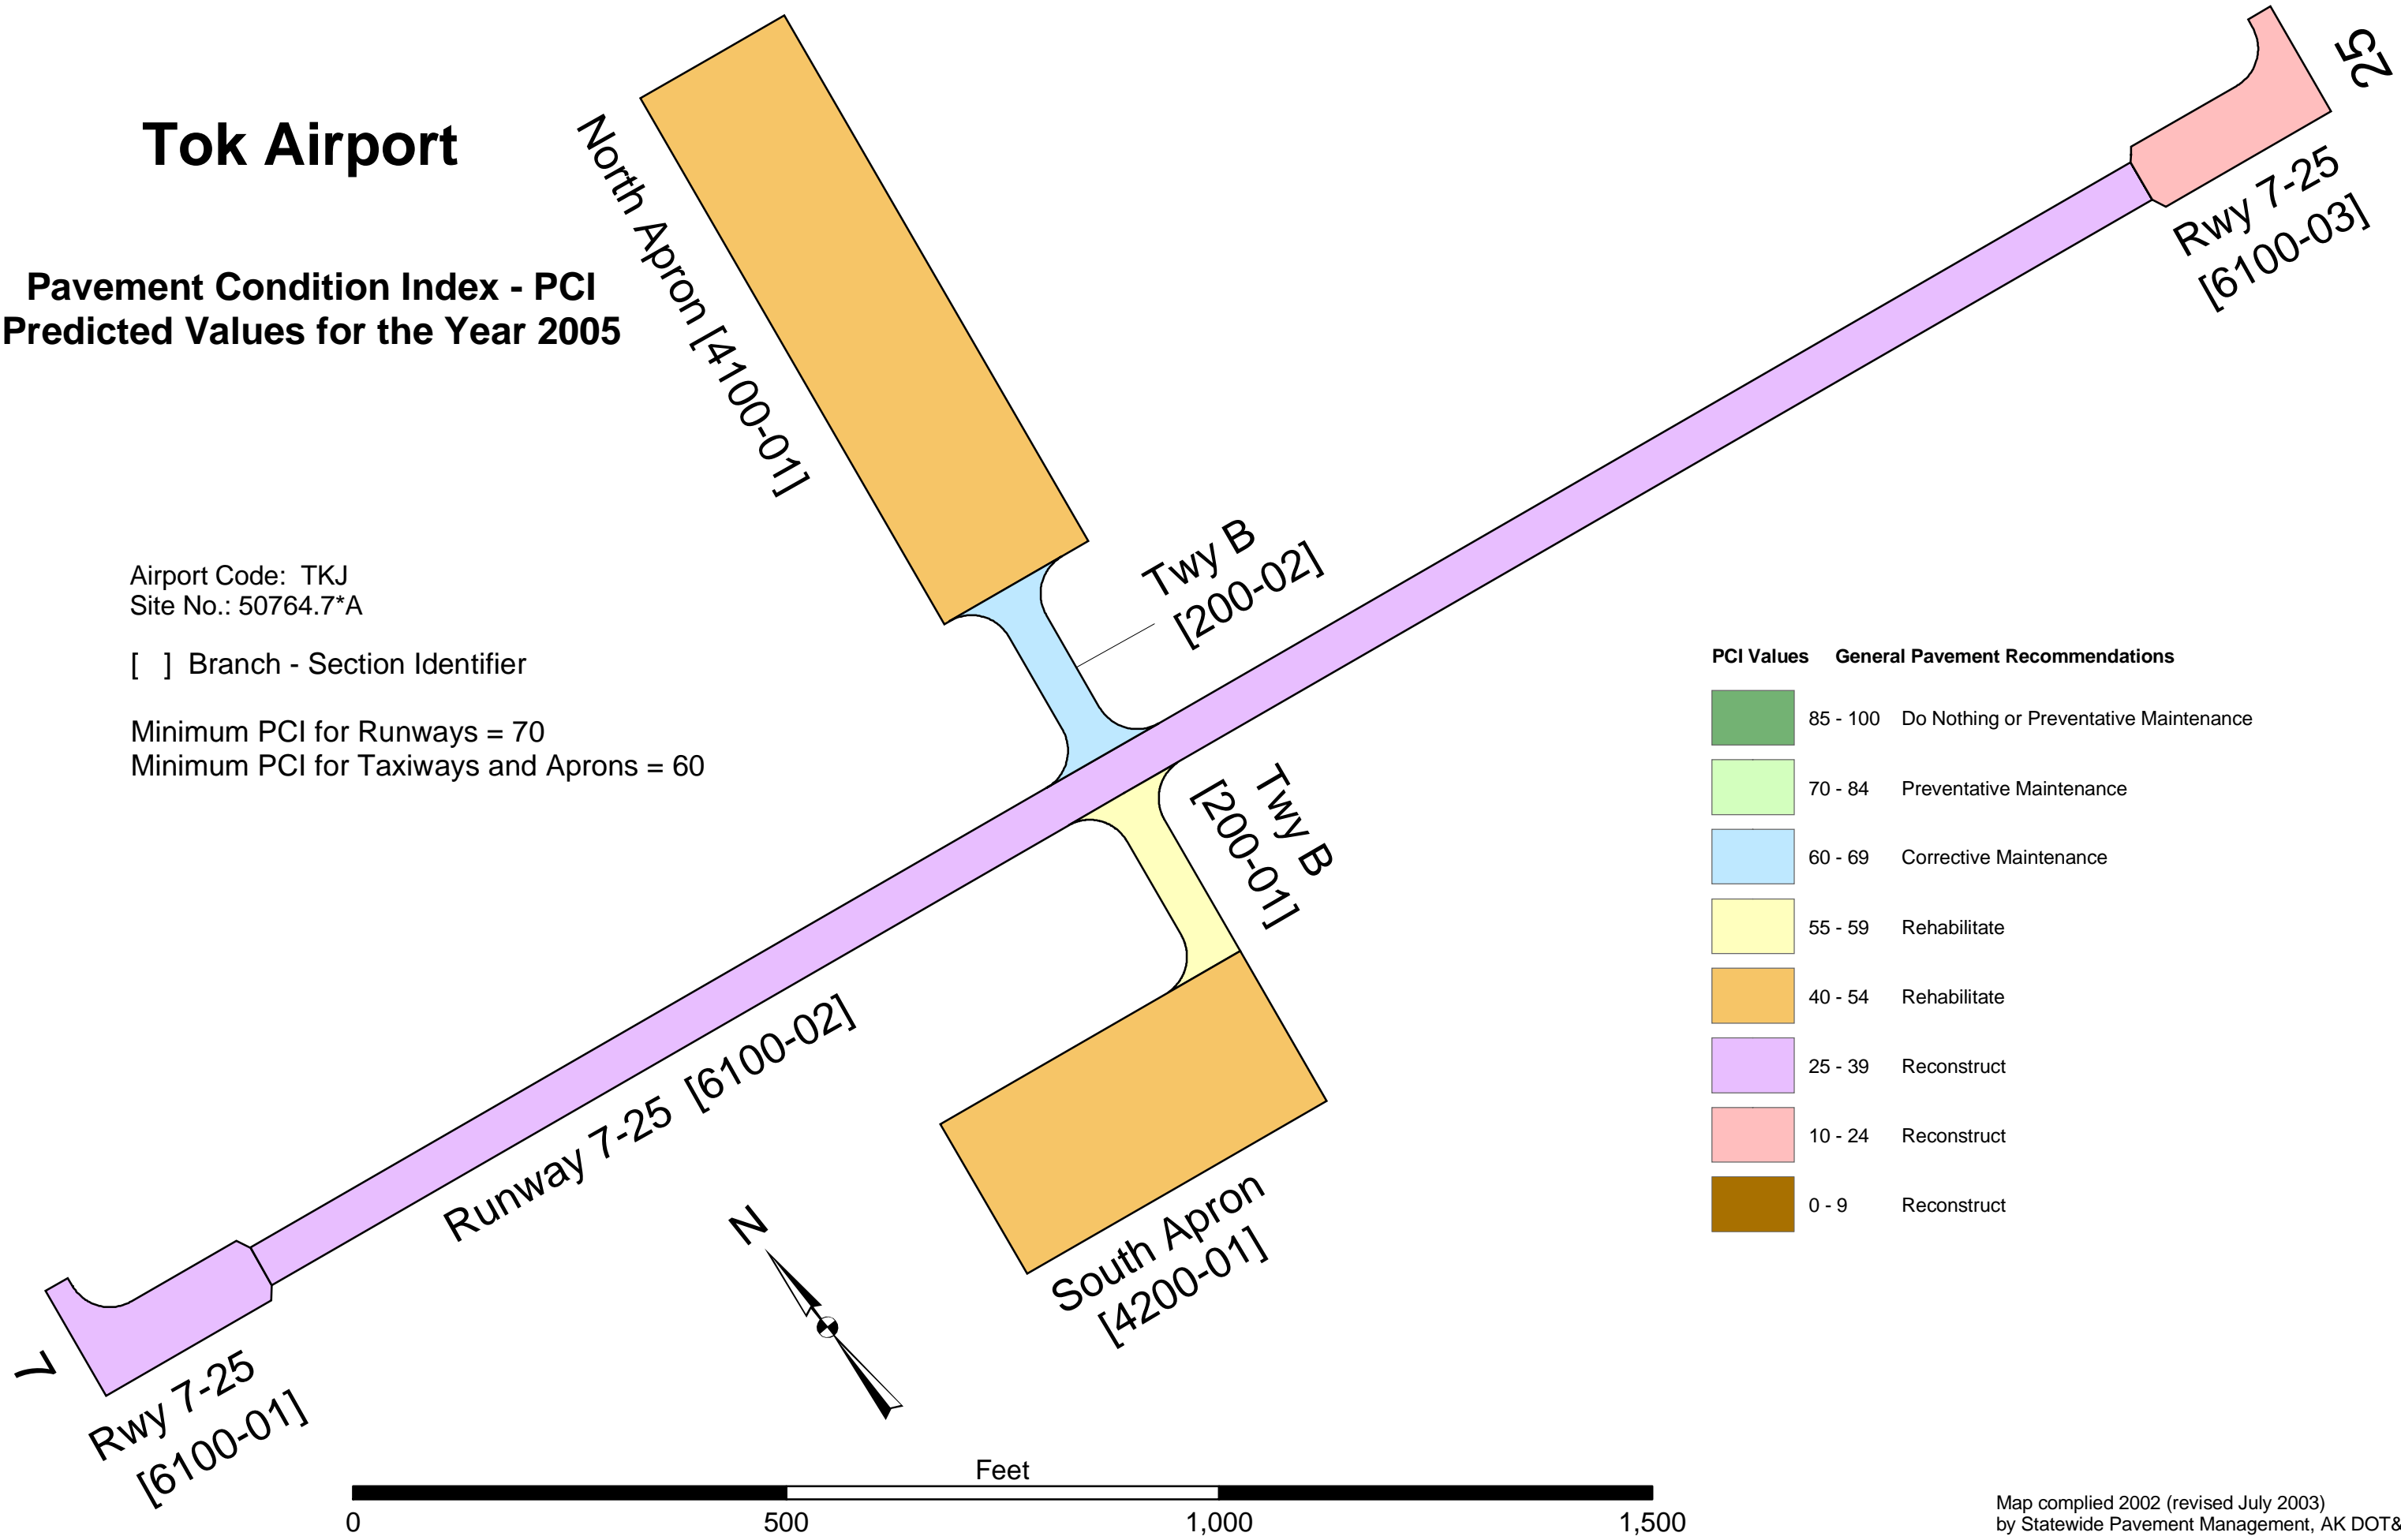
Pavement Condition Index - PCI Predicted Values for the Year 2005

Minimum PCI for Runways = 70
Minimum PCI for Taxiways and Aprons = 60

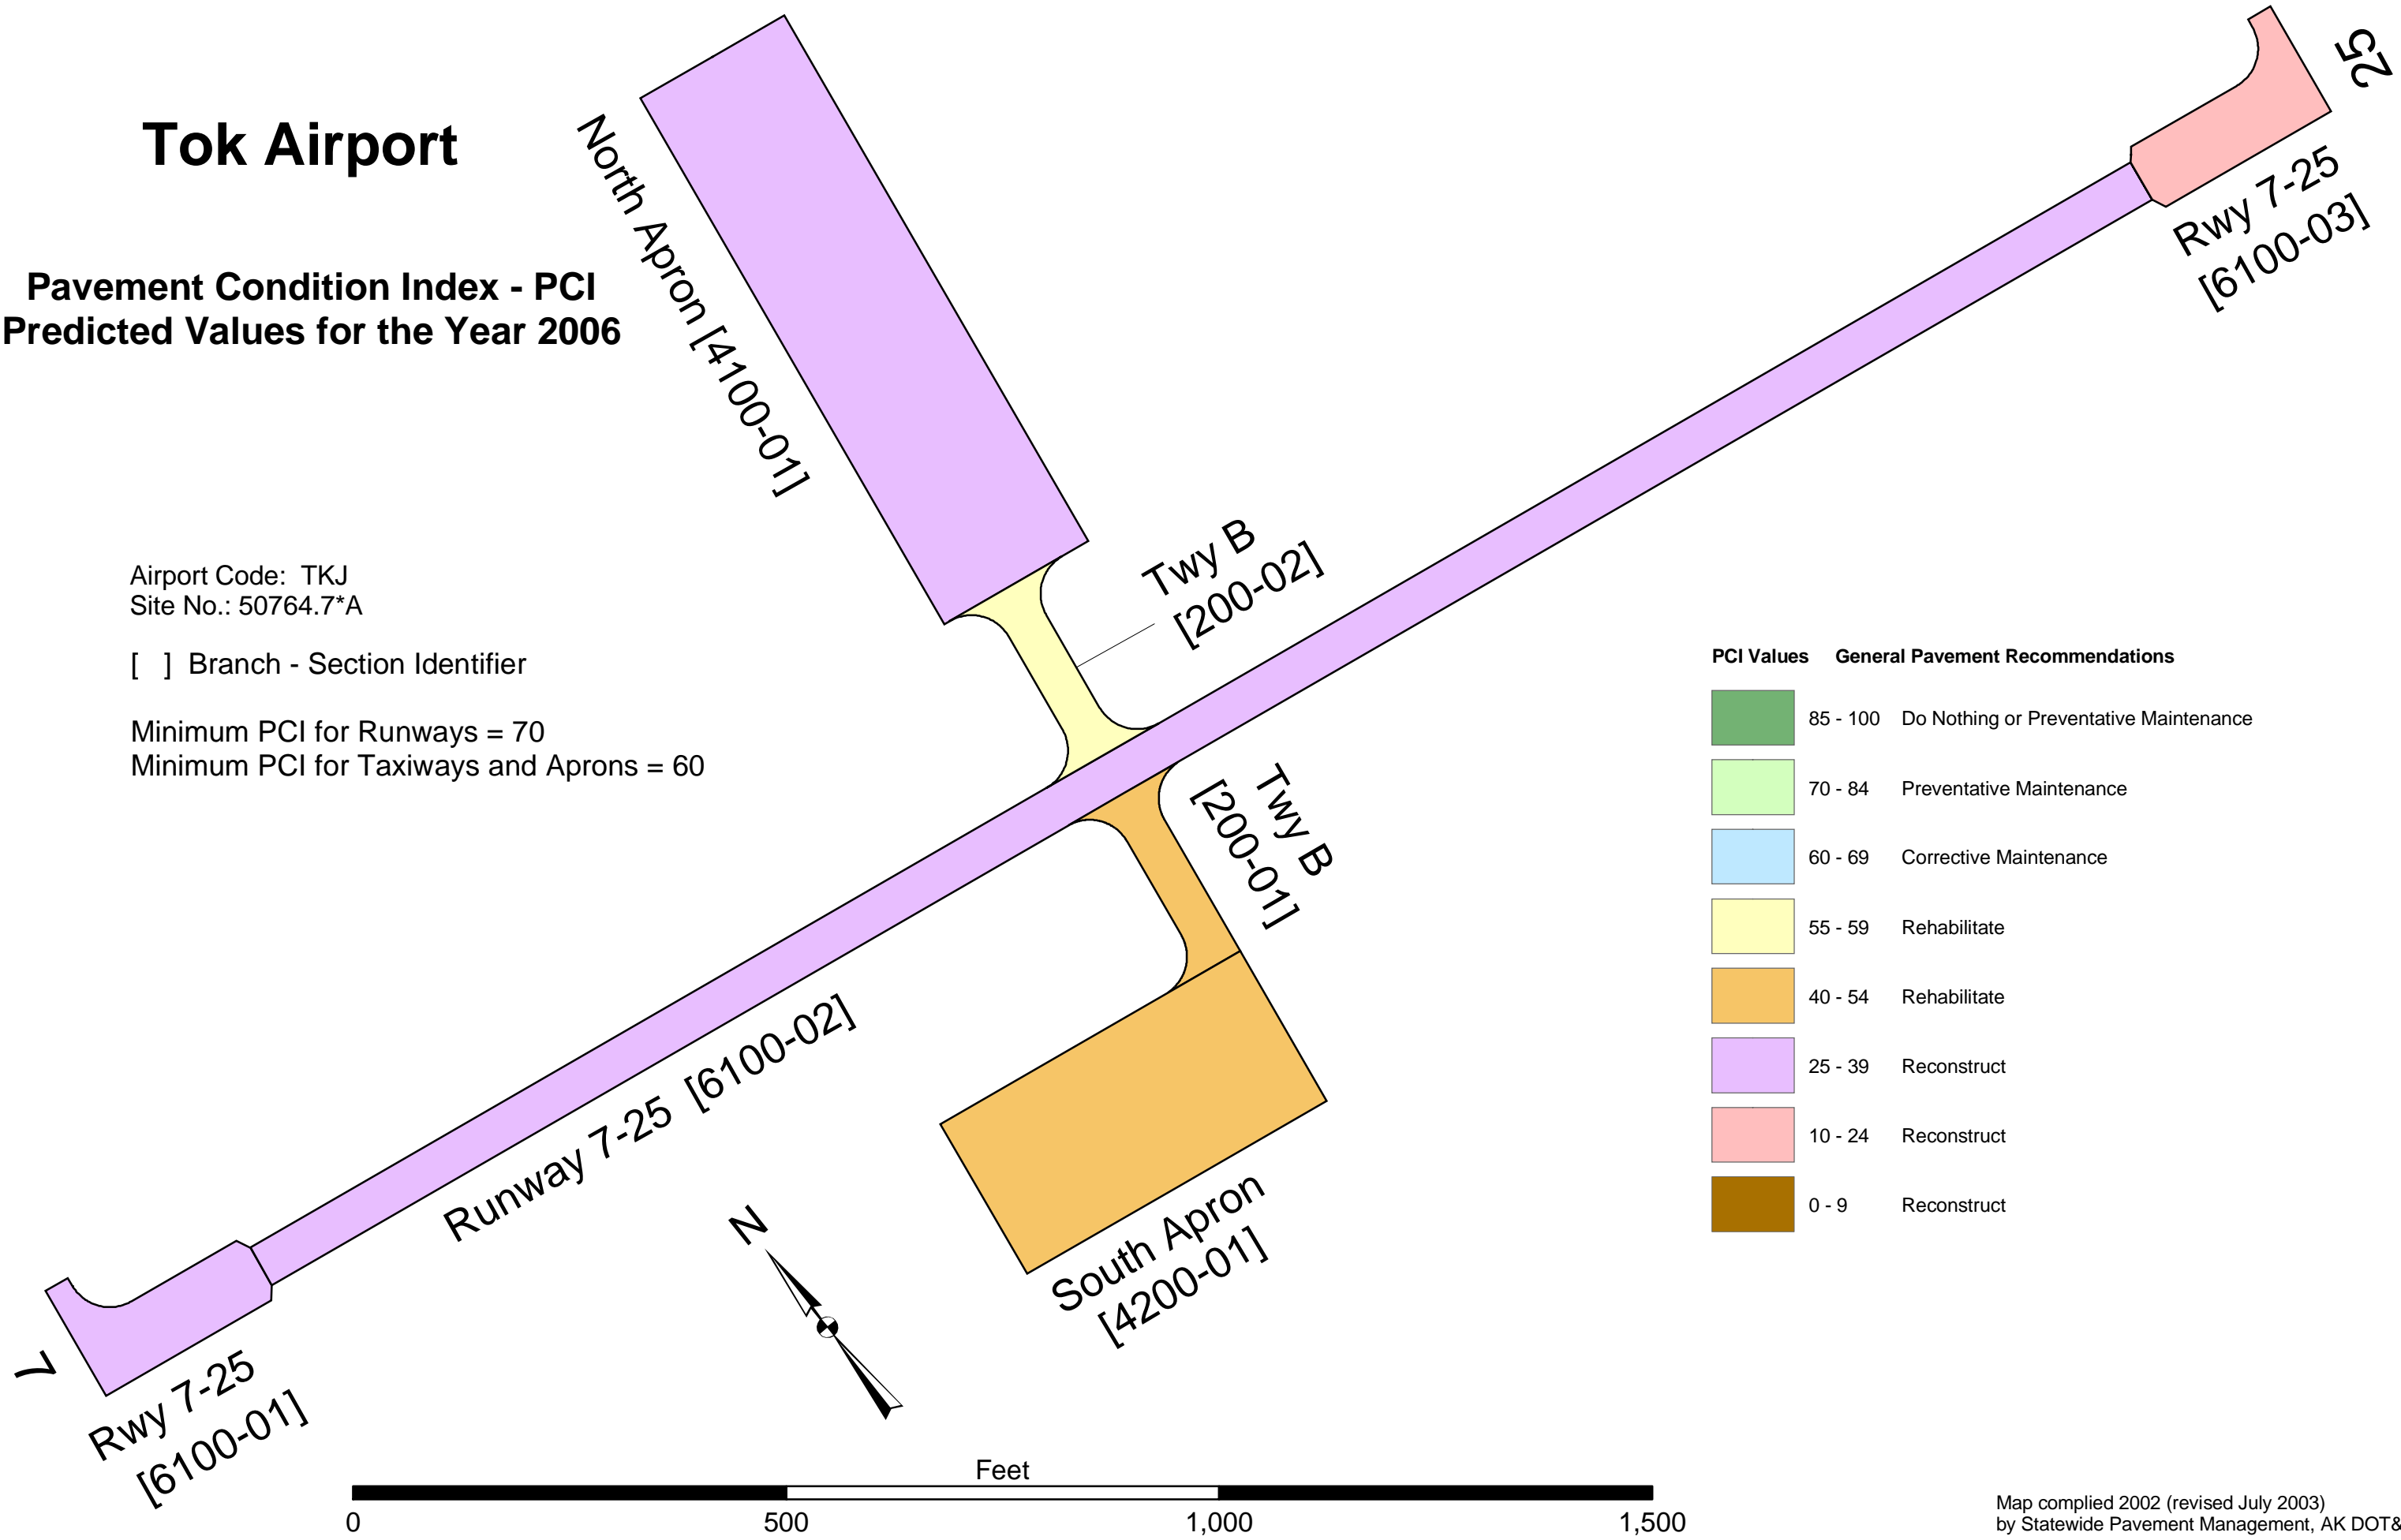
Pavement Condition Index - PCI Predicted Values for the Year 2006

Minimum PCI for Runways = 70
Minimum PCI for Taxiways and Aprons = 60
